## Valve Tappet Clearance

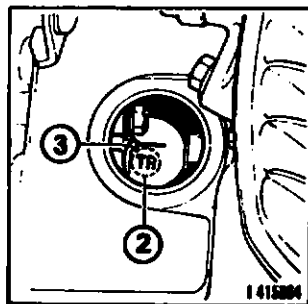
1. Desmonte la tapa agujero de marca de sincronización, tapa para agujero de cigüeñal y cubierta de la culata de cilindro.
2. Gire el cigüeñal (1) en la dirección del movimiento de las manecillas del reloj y alinee la marca "TR" (2) con la marca de índice (3). Asegúrese de que el pistón derecho esté en el punto muerto superior de la carrera de compresión tocando los levanta-válvulas con los dedos. Si los levanta-válvulas del cilindro derecho están libres, esto quiere decir que el cilindro derecho está en el punto
