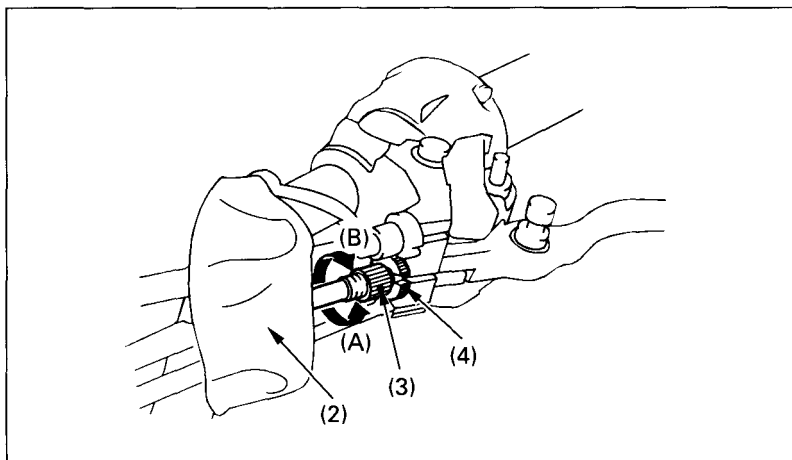
Fig. 4-18

- (1) Dust cover
- (2) Clutch cable adjuster
- (3) Lock nut

- (A) Decrease free play
- (B) Increase free play

3. If the cable adjuster is threaded out near its limit or the correct free play cannot be obtained using the cable adjuster (3), a major adjustment must be made. Loosen the lock nut (4) and turn in the cable abjuster (3) completely. Tighten the lock nut (4) and pull on the dust cover (2).
4. Install the handlebar cover securely. (Insert the fuel tank cap breather tube in the hole in the handlebar cover securely).
