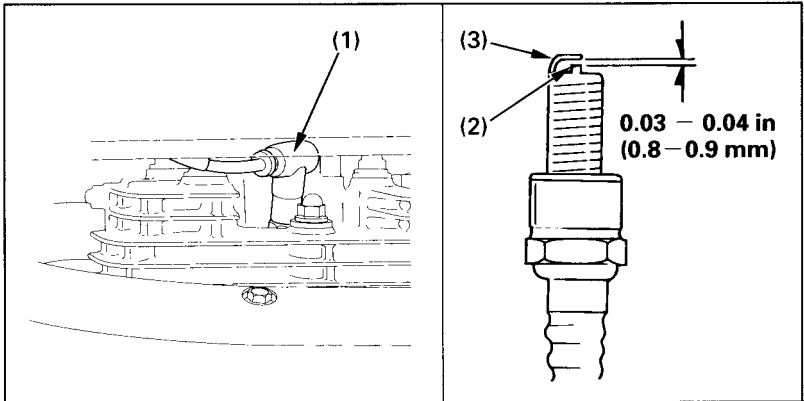
Fig. 4-16 (1) Spark plug cap

**The spark plug must be securely tightened. An improperly tightened plug can become very hot and possibly damage the engine.**

(2) Center electrode  
(3) Side electrode
